NASA TM-82409

## CONSIDERATIONS ON REPEATED REPAIRING OF WELDMENTS IN INCONEL 718 ALLOY

By E. O. Bayless, C. V. Lovoy, M. C. McIlwain,  
and P. Munafo  
Materials and Processes Laboratory

March 1981

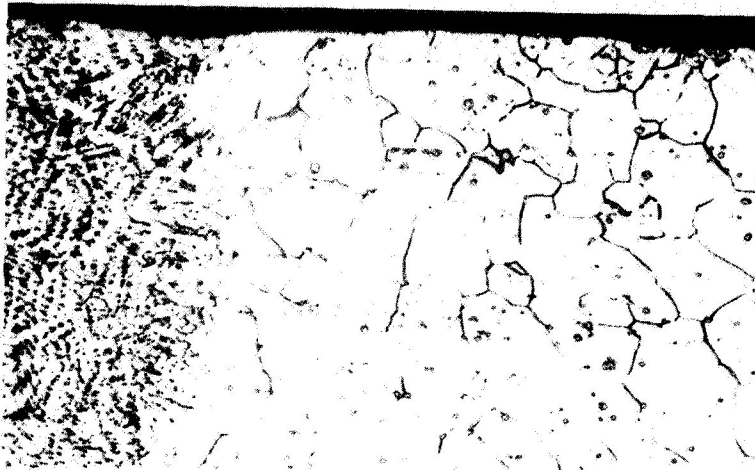
A. - Cross Section of a Composite Repaired Weld Joint and Base Material  
Mag. 5X

B. - Cross Section at Weld Interface: Cast Dendritic Structure of Weld at Left and Base Material Grain Structure at Right  
Mag. 100X

C. - Cross Section of Base Material  
Mag. 100X

Figure 13. Metallographic structures of panel containing two repeated weld repairs: STA after welding [1/4-in. (0.63 cm) thick plate Inconel 718].

The macrostructure of each fusion zone (base weld and all repeated repairs) revealed no porosity, crack or lack of penetration. In addition, no anomalies were evident in the microstructure of any weld (base or repair) fusion zone or adjacent base material. The metallographic structures for each experimental weld processing sequence are presented in Figures 12 through 18.

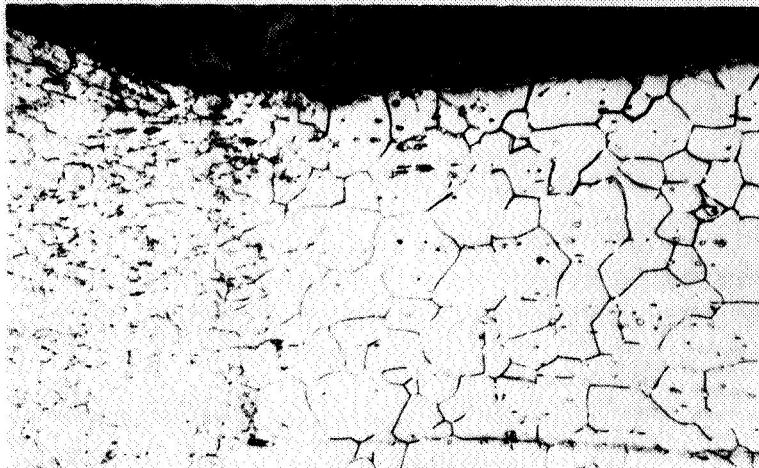
A. - Cross Section of a Composite Repaired Weld Joint and Base Material  
Mag. 5X

B. - Cross Section at Weld Interface: Cast Dendritic Structure of Weld at Left and Base Material Grain Structure at Right  
Mag. 100X

C. - Cross Section of Base Material Mag. 100X

Figure 15. Metallographic structures of panel containing twelve repeated weld repairs: STA after welding [1/4-in. (0.63 cm) thick plate Inconel 718].

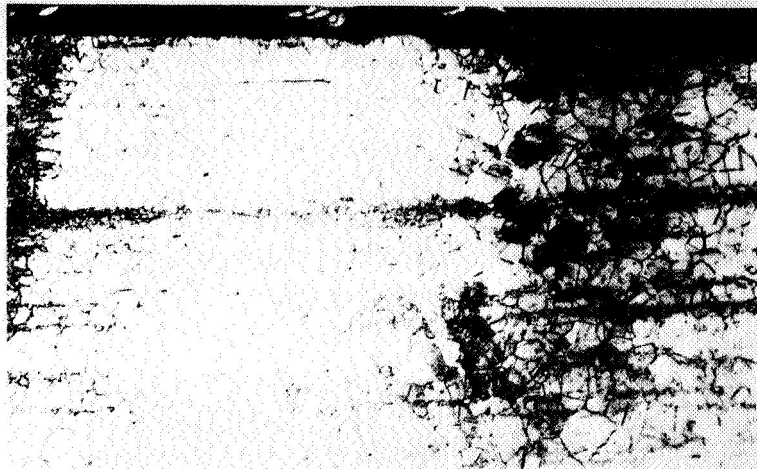
A. - Cross Section of a Composite Base Weld Joint  
and Base Material Mag. 5X

B. - Cross Section at Weld Interface: Cast Dendritic  
Structure of Weld at Upper Left Corner and Base  
Material Grain Structure at Right (HAZ) Mag. 100X

C. - Cross Section of Base Material Mag. 100X

Figure 16. Metallographic structures of panel containing base weld:  
As-welded STA base material [1/4-in. (0.63 cm)  
thick plate Inconel 718].

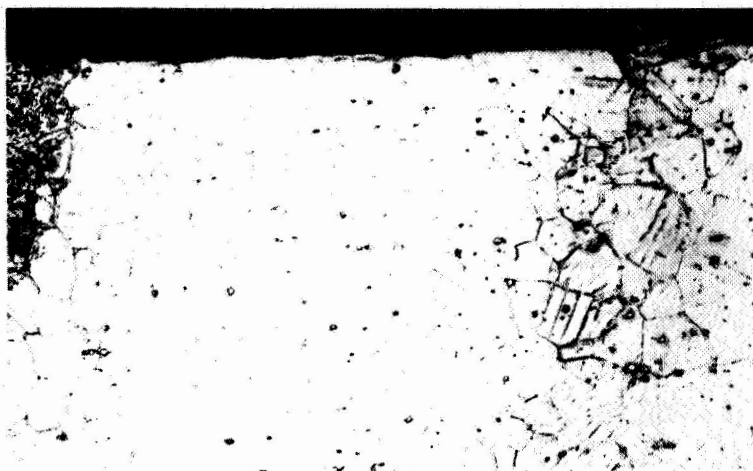
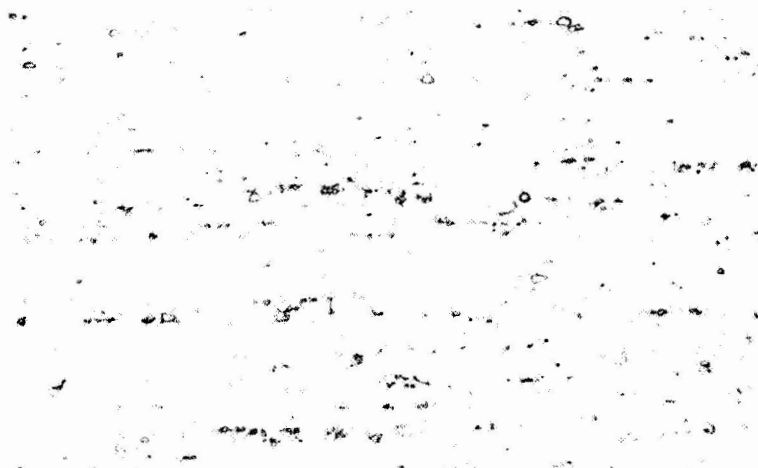
A. - Cross Section of a Composite Repaired Weld Joint and Base Material  
Mag. 5X

B. - Cross Section at Weld Interface: Cast Dendritic Structure of Weld at Upper Left Corner and Base Material Grain Structure at Right (HAZ) Mag. 100X

C. - Cross Section of Base Material Mag. 100X

Figure 17. Metallographic structures of panel containing two repeated weld repairs: As-welded STA base material [1/4-in. (0.63 cm) thick plate Inconel 718].

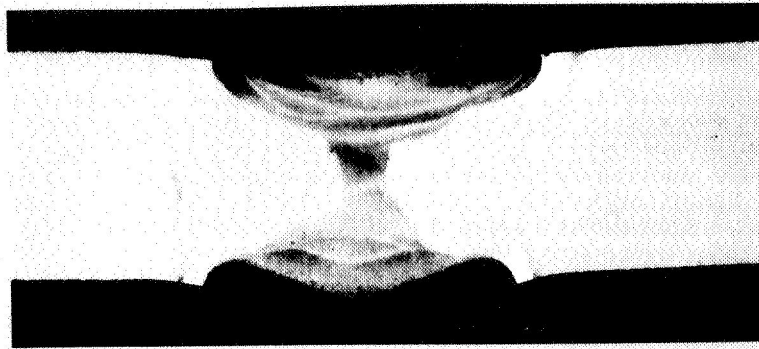
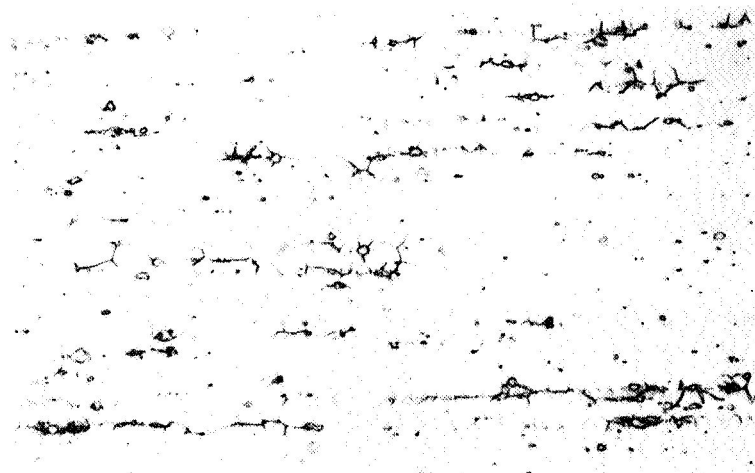
A. - Cross Section of a Composite-Repaired Weld Joint  
and Base Material Mag. 5X

B. - Cross Section at Weld Interface: Cast Dendritic  
Structure of Weld at Left and Base Material Grain  
Structure at Right (HAZ) Mag. 100X

C. - Cross Section of Base Material Mag. 100X

Figure 18. Metallographic structures of panel containing six repeated weld repairs: As-welded STA base material [1/4-in. (0.63 cm) thick plate Inconel 718].
